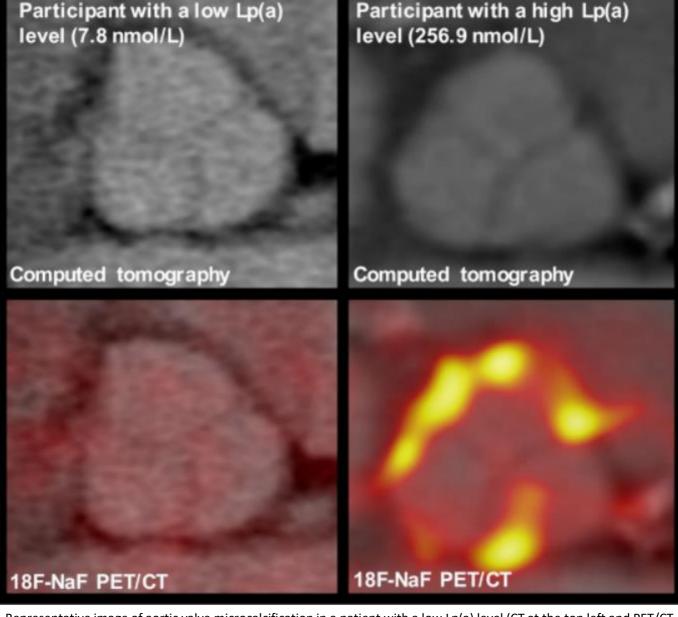
Representative image of aortic valve microcalcification in a patient with a low Lp(a) level (CT at the top left and PET/CT at the bottom left) and a patient with a high Lp(a) level (CT at the top right and PET/CT at the bottom right).
